Home Inspection Report

123 Any Street

Quohog, RI 02889

Inspected on Wed, Jul 4 2012 at 6:00 AM

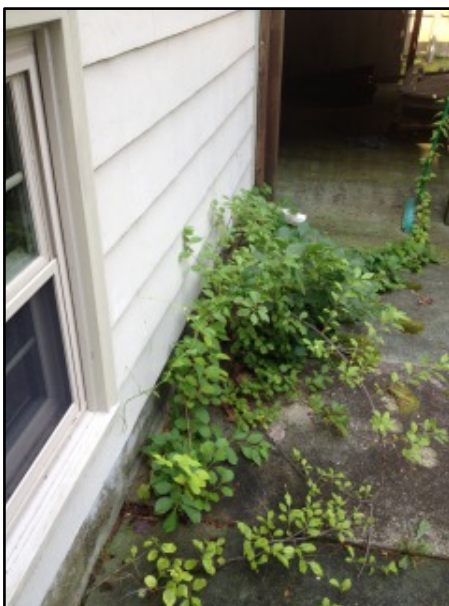
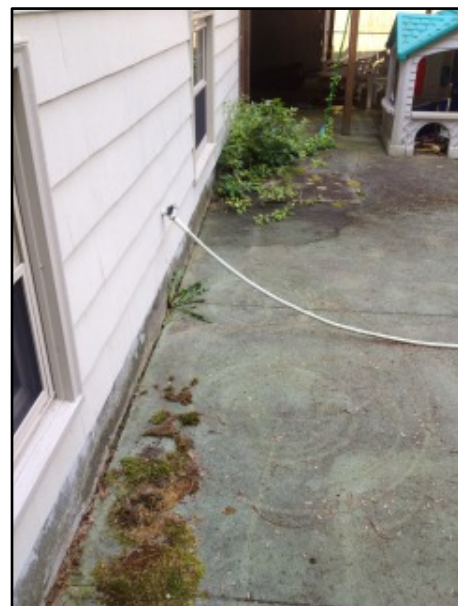
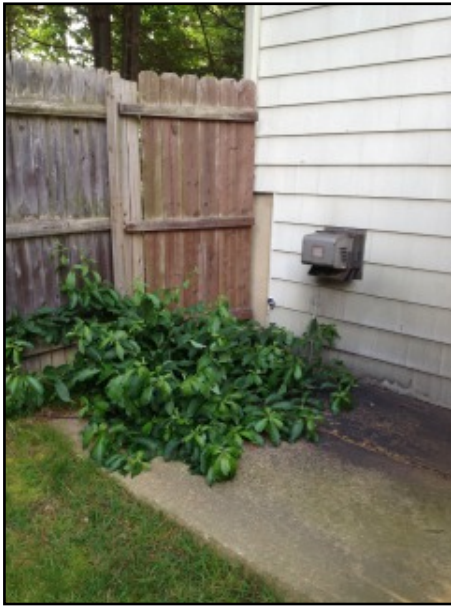
There was vegetation in contact with the exterior of the dwelling. Vegetation in contact with the exterior can cause premature deterioration of roof and siding, and make an easy entry point for pests. I recommend cutting back or removing vegetation so as not to contact the exterior of the dwelling.

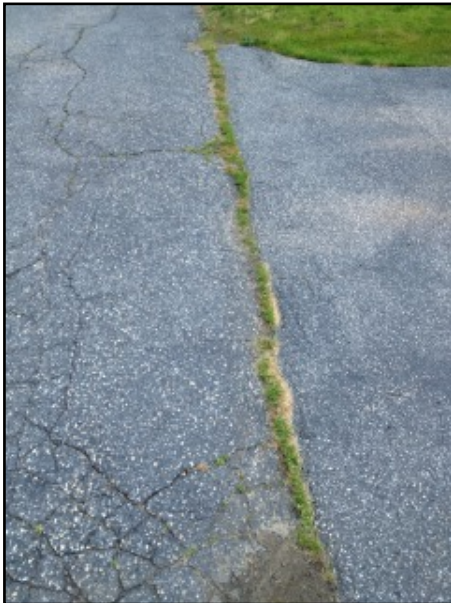
Figure 4-1

There was vegetation/plant life growing in the driveway/patio crack or seam. Allowing these plants to continue to grow will cause increased deterioration of the driveway/patio. I recommend removing these plants and treating to prevent further plant growth.

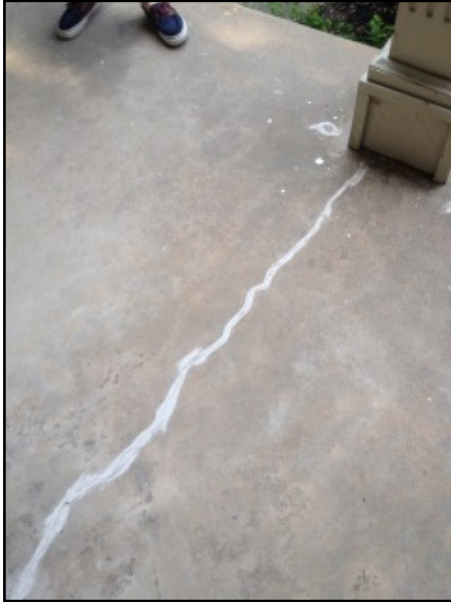
Figure 5-1

There was a small crack on front patio. Due to items observed, crack appears cosmetic in nature, only a very minor deficiency.

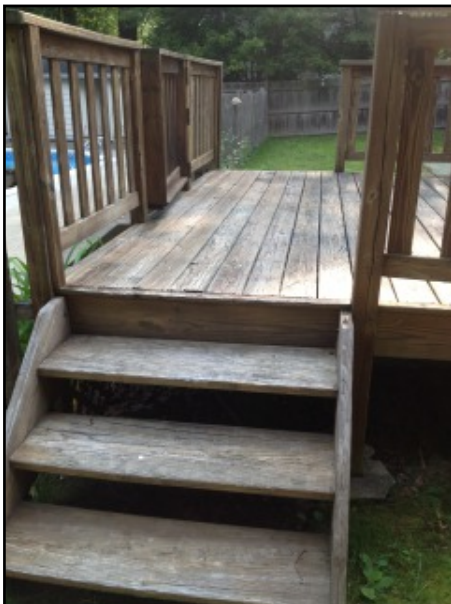
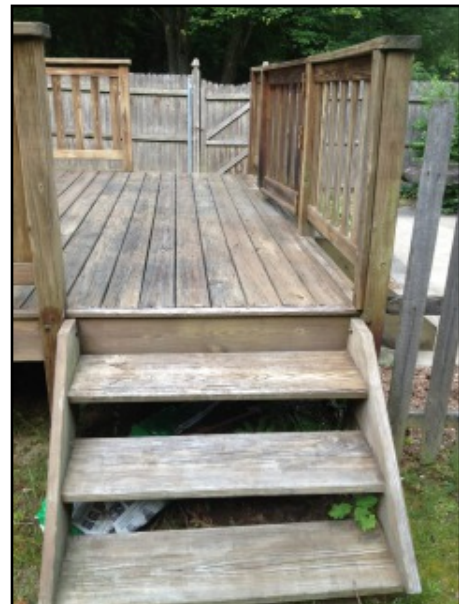
Stairs rising over 30 inches did not have a handrail. Recommendation: install proper handrails on any stairs rising over 30 inches in height with proper baluster spacing of 4 inches or less for safety.

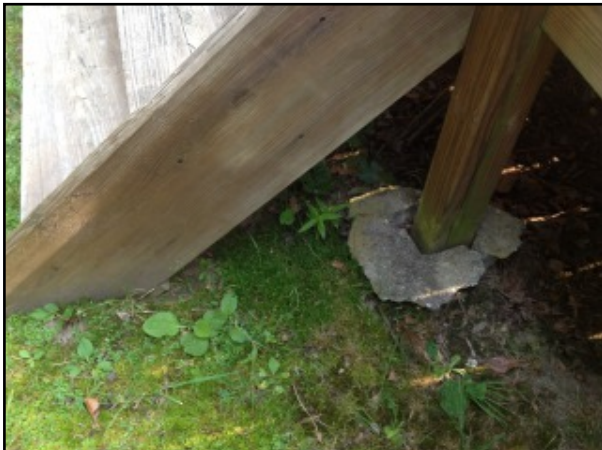
Figure 7-1

The support columns for the deck had improper footings. These footings have not been installed properly allowing both contact between wood and soil as well as water collection around the columns. This condition can decrease the life span of structural components. I recommend consulting a qualified contractor for the most appropriate techniques for repair.

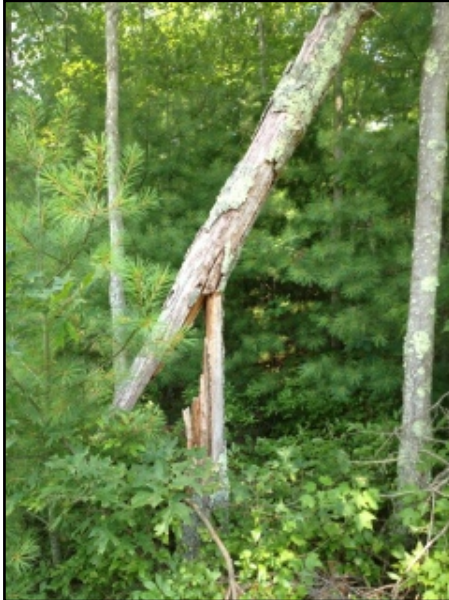
Figure 8-1

On the rear left side of the property there was a broken tree. This tree has not completely fallen and is a hazard. Leaving this tree in this position invites the risk of injury as it may fall injuring someone. I recommend removal of this tree by a licensed, qualified arborist.

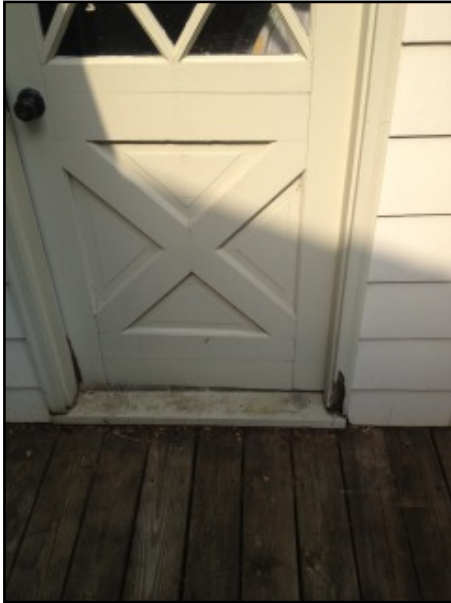
Figure 9-1

Some of the wood trim around the rear entry door was rotted and had peeling paint. All wood should be painted to protect from further moisture inclusion in damage from the elements. Leaving soft or rotted wood will allow the decay to spread to other areas and allow easy water and pest entry. I recommend replacing any soft or rotted wood. This is a relatively minor repair.

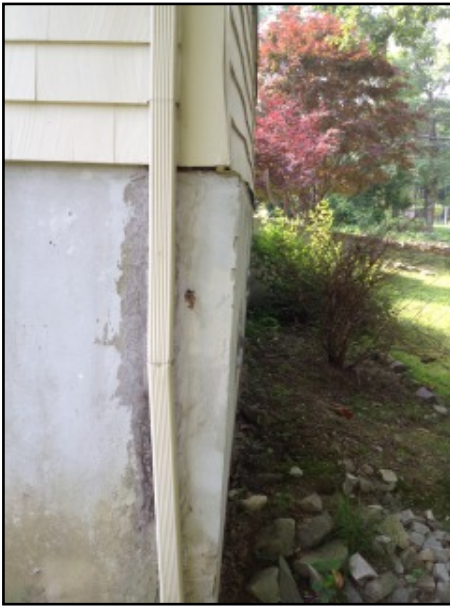
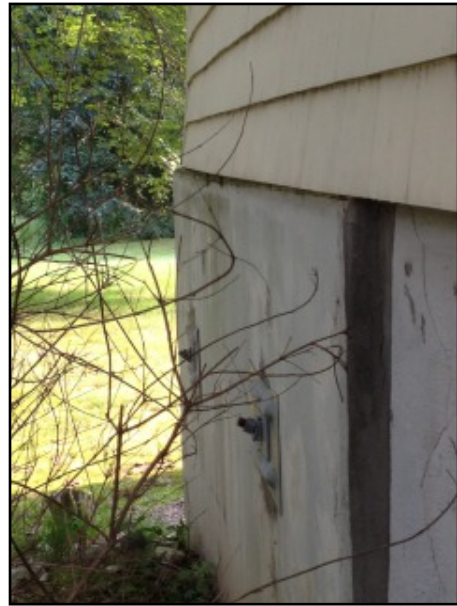
The exterior foundation wall was repaired approximately 10 years ago by a licensed contractor and movement has stopped since repair performed. The buyer has been presented with engineered, stamped papers stating wall was properly repaired. In the opinion of this inspector the wall has not moved since proper repair has been performed, in all likelihood the wall is stable where it is. No further movement is expected. If any displacement occurs, contact a licensed, qualified contractor immediately.

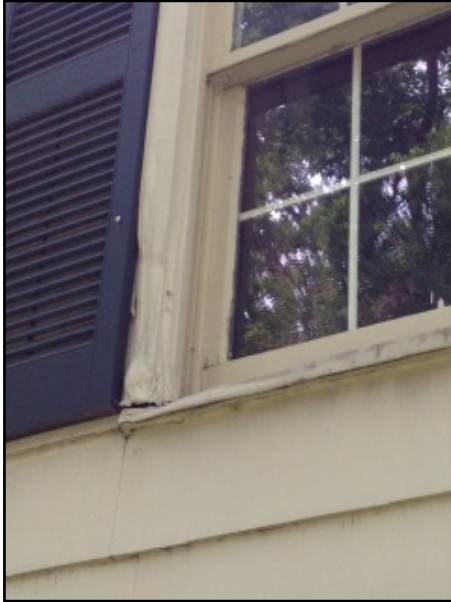
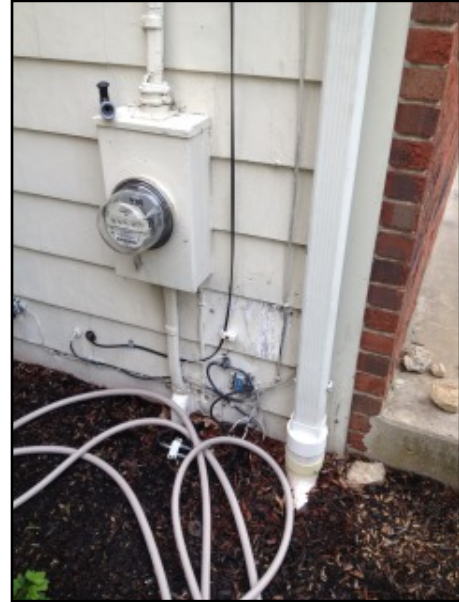
The wood around this window and trim adjacent to the electric meter had begun to rot and become soft. I recommend repairing all of these damaged areas to prevent further rot, damage and water intrusion. These are relatively minor repairs.

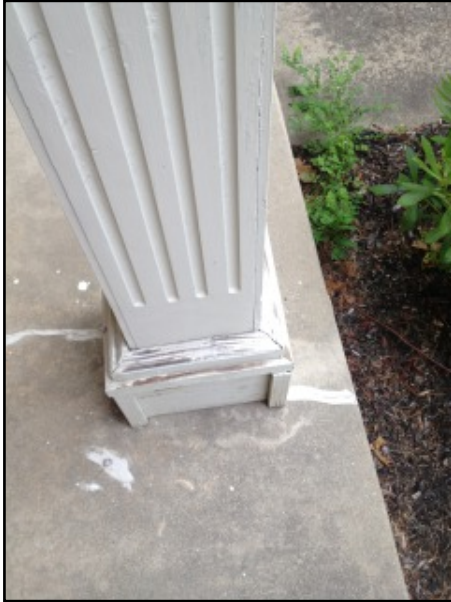
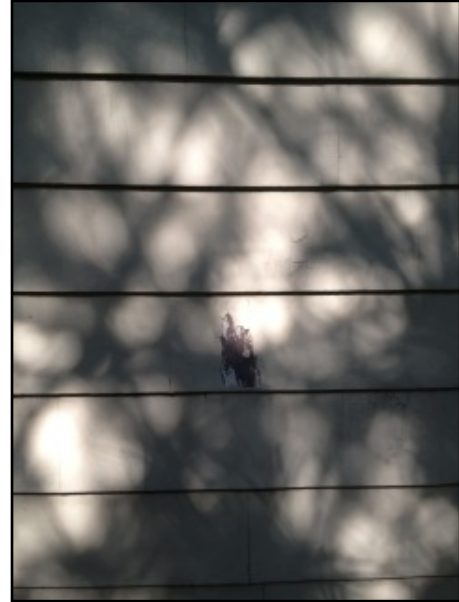
Several small areas around dwelling had exposed wood. These areas should be painted so as to protect them from water intrusion. At this time there has been very little or no water damage, the preventative maintenance of keeping the paint system up to date will prolong the lifespan of the dwelling exterior.

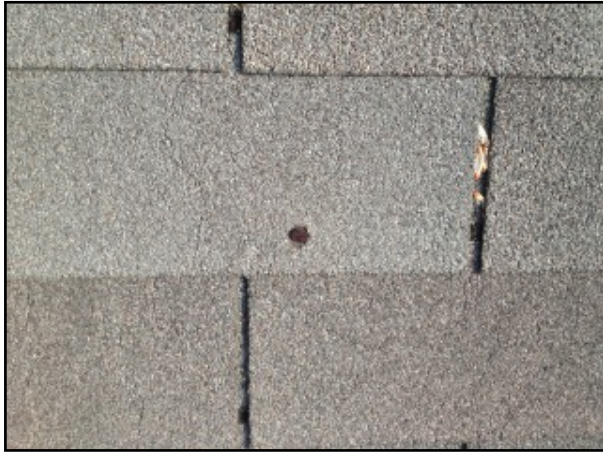
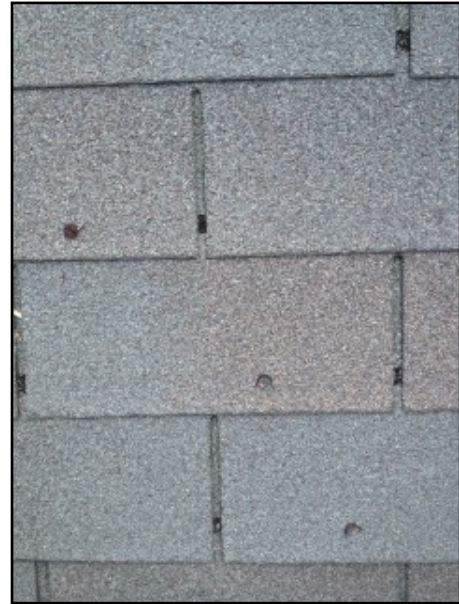
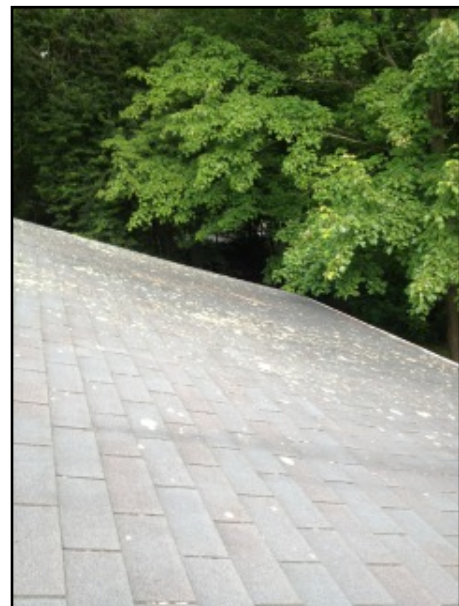
Roofing areas displayed signs of wear and tear including many granules have been worn off. Also some nails heads have penetrated roof shingles due to wear and tear. There was moss on backside of garage roof. Some areas of flashing on the chimney are worn as well.

This roof will likely require repair or replacement within the next 3 years.

Overall the roof on this dwelling is approximately 15 years old by inspector estimation. In a likely scenario the roof will need replacement in the next couple years as it is reaching the end of its serviceable life

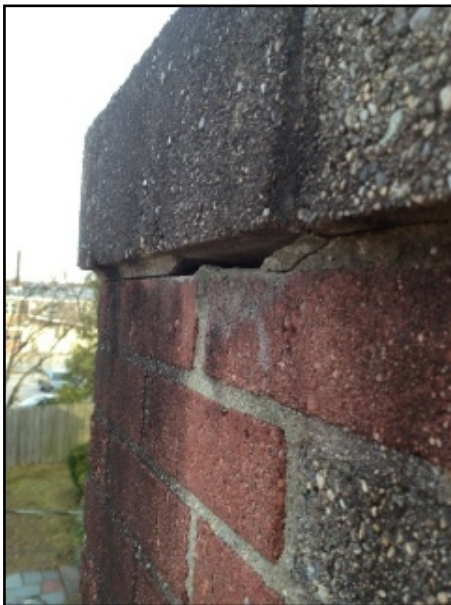
Figure 15-1

Some of the mortar was cracked and missing on the chimney (fig 15-1). This can allow water to enter and cause damage. It requires repointing.

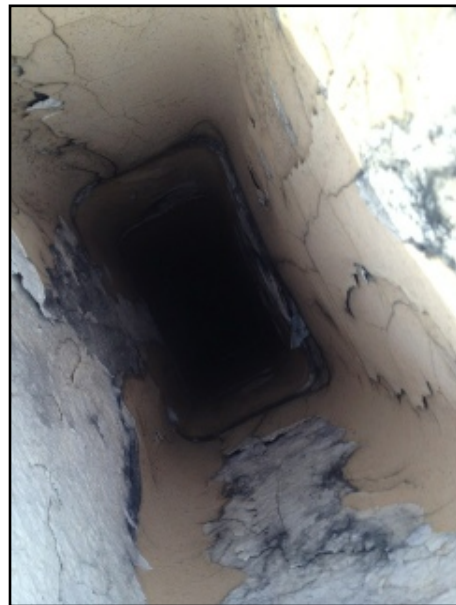
Figure 15-2

The chimney liner for the heating system flue (fig 15-2) is cracked and brittle. I recommend evaluation by a licensed chimney sweep internally inspected. This liner has begun to deteriorate and may require replacement.

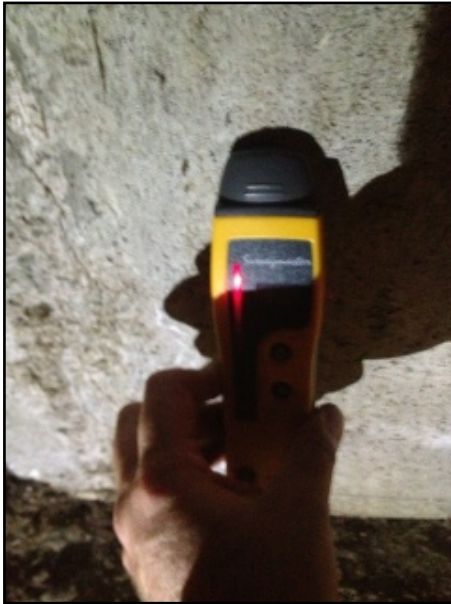
Figure 16-1

The foundation wall displayed an elevated moisture level. The basement area was not finished. This was not a serious condition as the structure of the wall has not been compromised. You may consider taking precautions on the exterior such as a perimeter drain or properly diverted gutters to keep moisture levels low. At a minimum I recommend running a dehumidifier to keep moisture levels in the basement low.

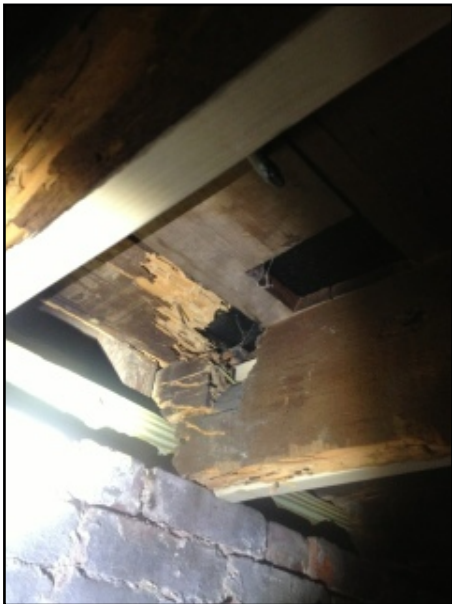
Figure 17-1

Comment 17:
There was significant WDO (wood destroying organism) damage to several floor joists and sill plate. The areas have been repaired. Some areas of the repair do not appear adequate. I recommend consulting with a licensed, qualified contractor to determine the best course of repair required.

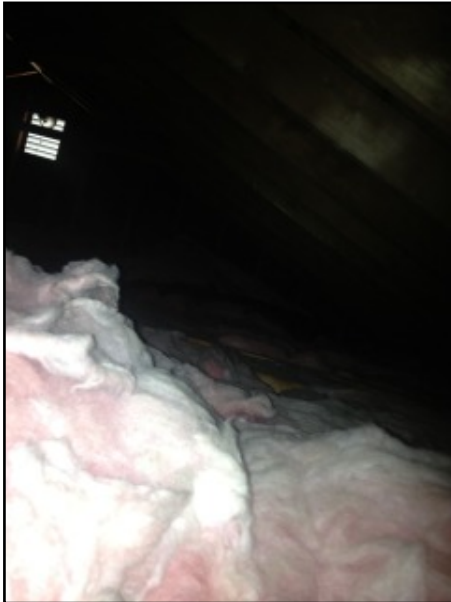
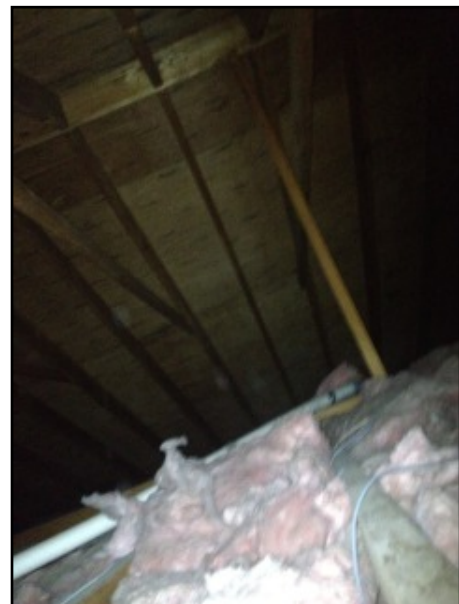
The attic access space was very small. The inspector was only able to inspect by visual from attic opening in linen closet. From the limited view, the roof sheeting appeared to be in satisfactory condition. Also there appeared to be adequate insulation in attic.

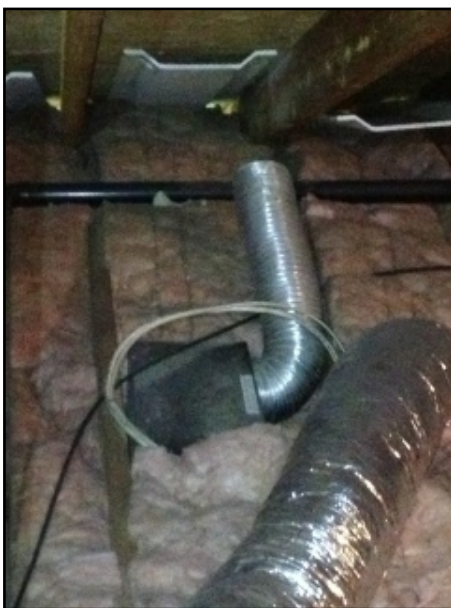
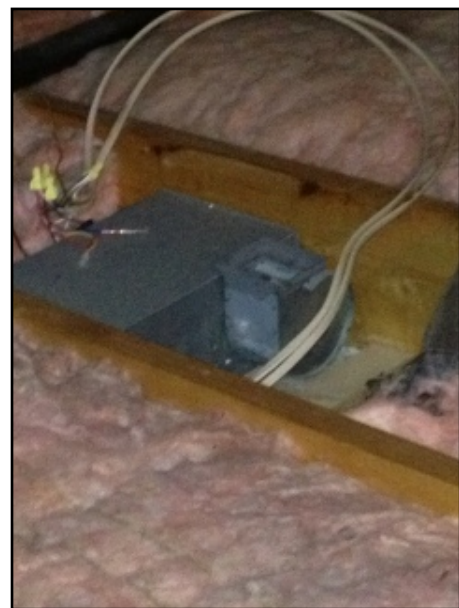
Both upper-level bathroom ventilators discharged into the attic space. It is strongly recommended that all that ventilators exhaust to the exterior of the building. Venting bathrooms into the attic only moves moisture from the bathroom into the attic area, creating a potential mold issue. I recommend installing vent systems that vent directly to the exterior of the dwelling. I recommend each vent having a separate exhaust to the exterior, combining vents could potentially pump moist air from one bathroom and backflow into the other bathroom.

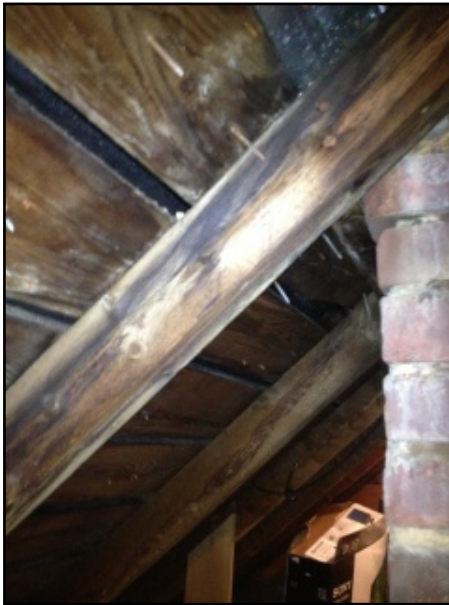
Figure 20-1

There was some minor staining on the roof sheeting and structure visible in the attic area. This is an older home and it is likely that the previous roof did leak and stain the wood. The moisture meter test indicated no elevated moisture in this area. This lack of moisture indicates a cosmetic stain and not an active leak. There was no softened or rotted wood visible in the attic area.

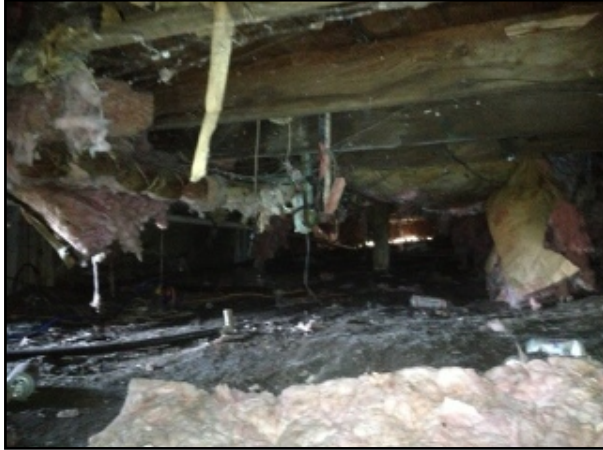
Figure 21-1

The insulation located in the crawlspace was in poor condition and requires replacement. There was no vapor barrier present. This can cause poor energy efficiency. I recommend a licensed, qualified contractor install new insulation and vapor barrier throughout the crawlspace.

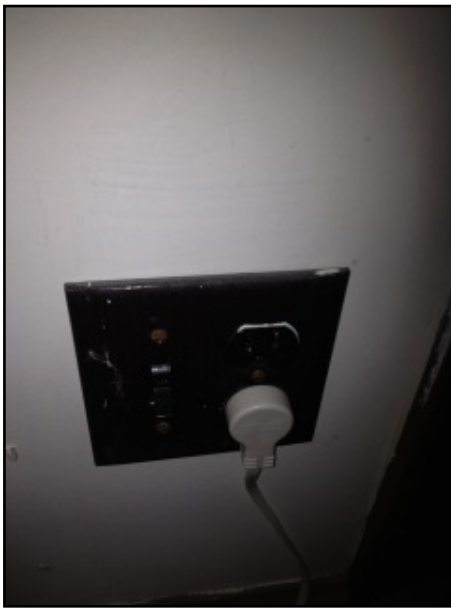
Figure 22-1

The receptacle had an open ground conductor-The house was originally wired with a two-wire, non-grounding type electrical system. There were three-pronged (grounding-type) receptacles, which require utilization of an equipment grounding conductor, that were installed on the two-wire ungrounded branch circuits. Appliances, fixtures and other equipment that require a three-pronged (grounding-type) receptacle will not be afforded the necessary protection of a grounding conductor, which could result in personal injury or damage to the equipment. You should consult with a qualified electrical contractor to determine alternatives for grounding the branch circuits in specific areas, or for bringing the receptacles into compliance with current safety standards, which would include installation of GFCI protection at the branch circuits and affixing warning labels to the receptacles, or replacing the receptacles with a non-grounding type receptacle.

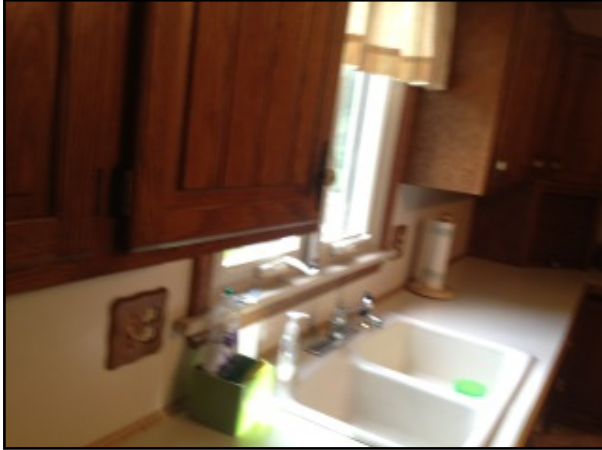
Figure 23-1

The receptacle was found to lack GFI protection-All receptacles that service kitchen countertops, bathrooms, exterior, garage, and other wet areas are required to be GFI protected. A GFI protected receptacle offers additional protection to appliances and personnel. A non-protected outlet has increased risk of shock and damage to appliances. I had electrician evaluate and provide the proper solution for this condition.

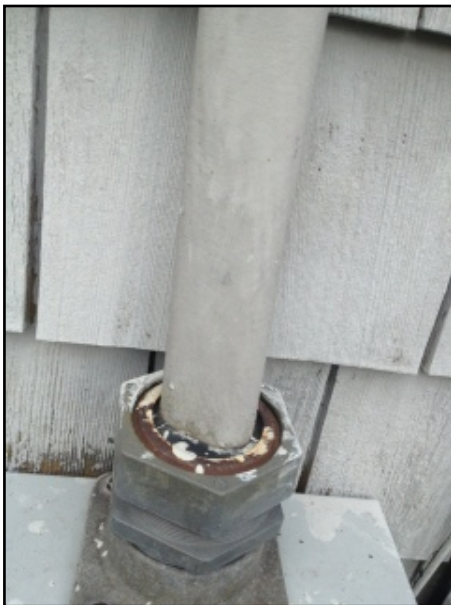
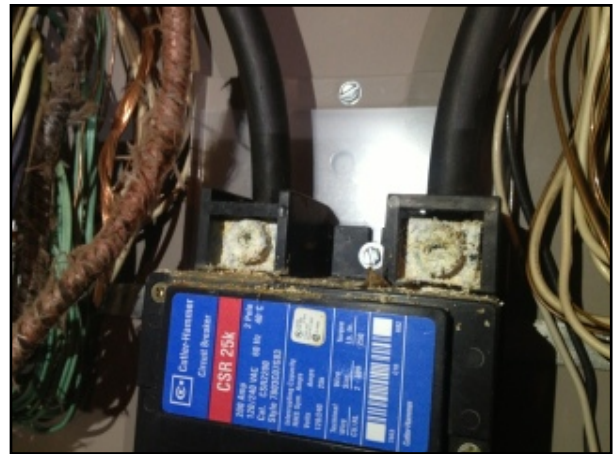
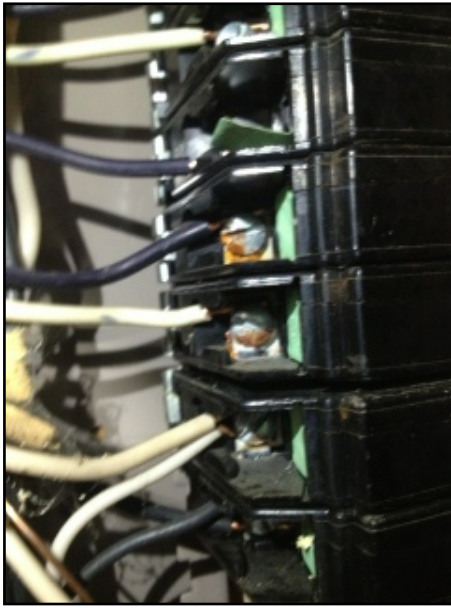
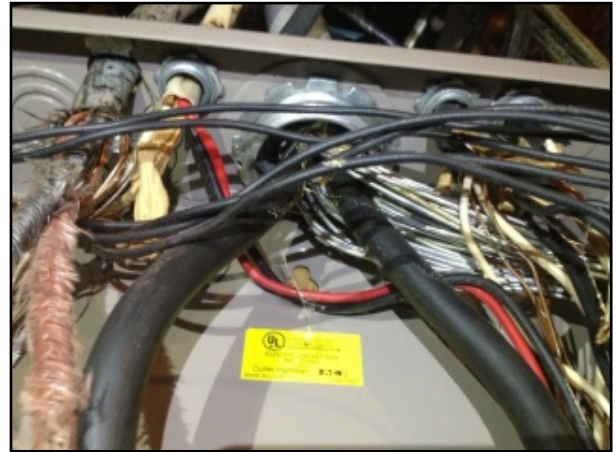
The interior portion of the main service panel had a significant amount of corrosion visible. The panel also displayed signs of water penetration. The duct seal on the main electrical service line (exterior) was not present allowing water to follow the main service line towards the panel.

Any corrosion located inside a service panel or on any electrical device is considered a major hazard and should be remedied immediately by a qualified, licensed electrician. Corroded portions of electrical circuits are a fire hazard.

I recommend evaluation and repair by a licensed, qualified electrician.

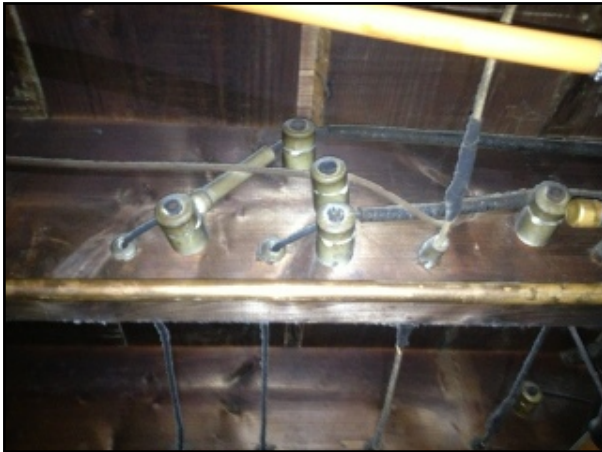
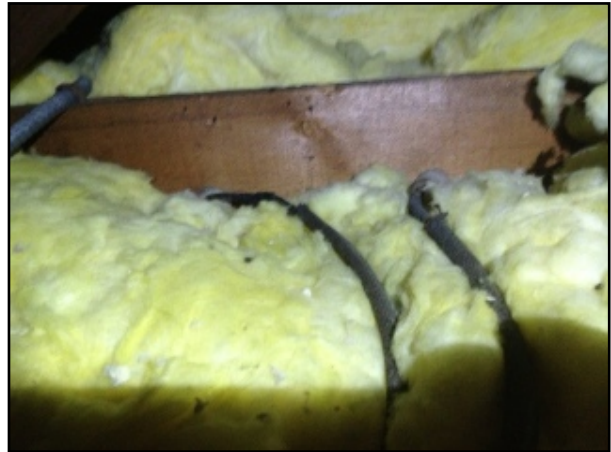
This home had active knob and tube wiring circuits present. Knob and tube wiring circuits are an older style of wiring (typically used until the 1930's). It should be noted that this type of wiring was designed for a lower electricity demand than many current homes require. This type of wiring also requires open air surrounding circuits to keep the wires cool. It should not be covered in insulation as heat can build up causing a fire hazard. Knob and tube wiring circuits should not be extended or added to. I also recommend all knob and tube circuits be run on a 15 amp breaker (maximum) to further reduce the possibility of overheating circuitry and fire hazard. Please consult a licensed, qualified electrician prior to servicing, modifying, or repairing any electrical system in the home.

In the attic area, there was knob and tube wiring covered in insulation, creating a fire hazard. It is important that this insulation around the knob and tube be removed. Please consult a qualified electrician for exact clearances required to eliminate a fire hazard.

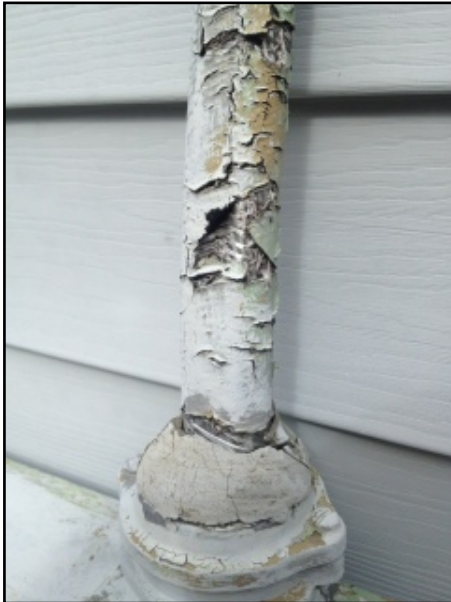
Figure 26-1

The main electrical service line jacket was deteriorated. This condition can allow water to enter the line, meter, and main service panel. This can cause deterioration of the components and is a major hazard. I recommend having this repaired by a licensed, qualified electrician immediately.

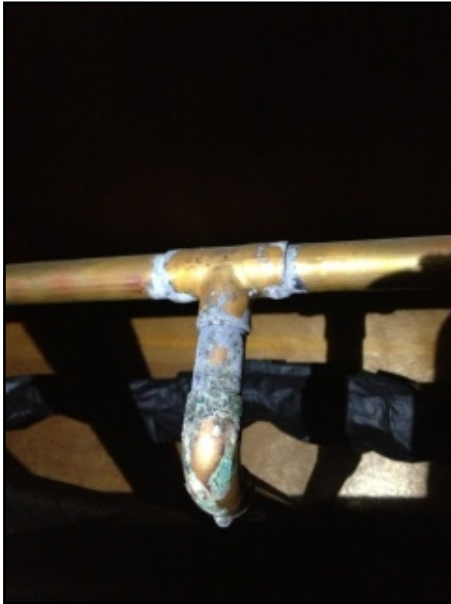
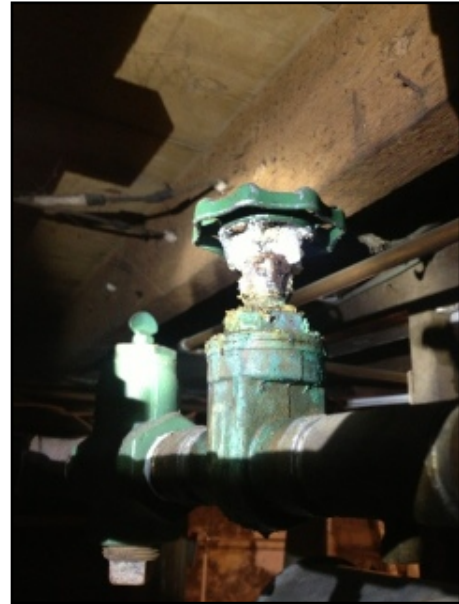
The plumbing had deterioration/corrosion. It will leak in the near future. I recommend having these areas replaced as necessary by a licensed plumber.

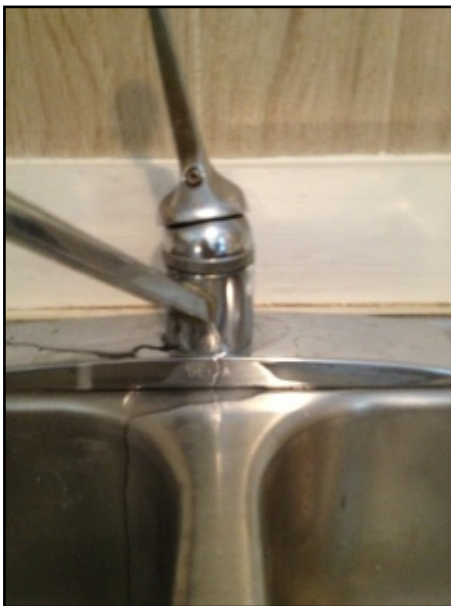
Figure 31-1

The main kitchen faucet leaked from the fixture when in operation. Due to the price point of the style faucet, I recommend replacement rather than repair.

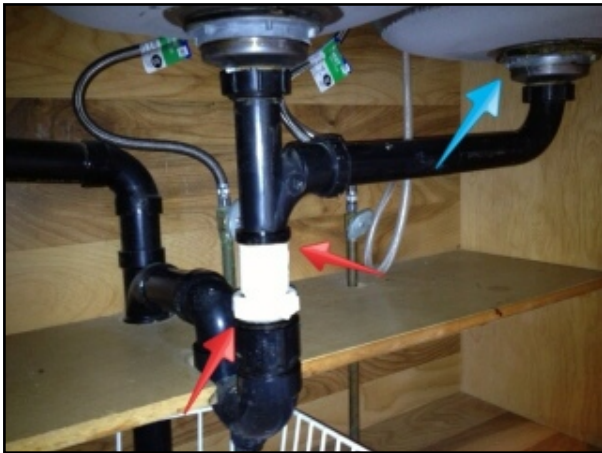
Figure 33-1

The drain under the kitchen sink had multiple defects and should be replaced or reconfigured by a licensed plumber. Note: even though this plumbing is not configured in the traditional manner, it did not leak during the inspection. Because the materials and techniques used are not approved by current building standards, I cannot endorse the continued operation of this drain system.

The red arrows indicate improper coupling of plumbing joints. These areas should be correctly configured with the proper compression fittings to prevent water leakage.

The blue arrow indicates an excessive amount of what appears to be a silicone sealant like caulk. This is not the proper technique and was likely an amateur repair under the sink.

Also the drain line entering the drain system from the left of the photo does not have a trap.

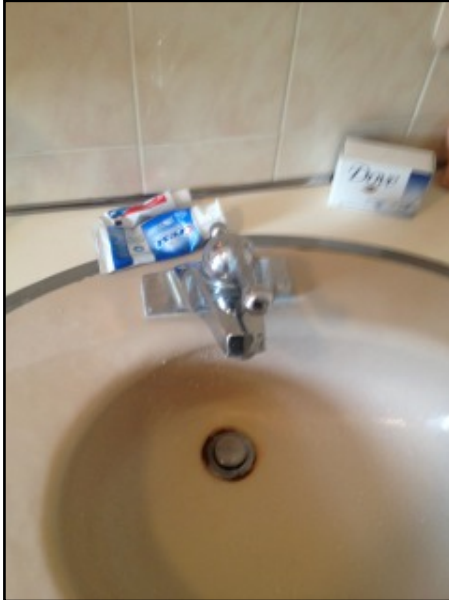
Figure 37-1

The bathroom sink faucet had slow drip. I recommend repair or replacement of the faucet.

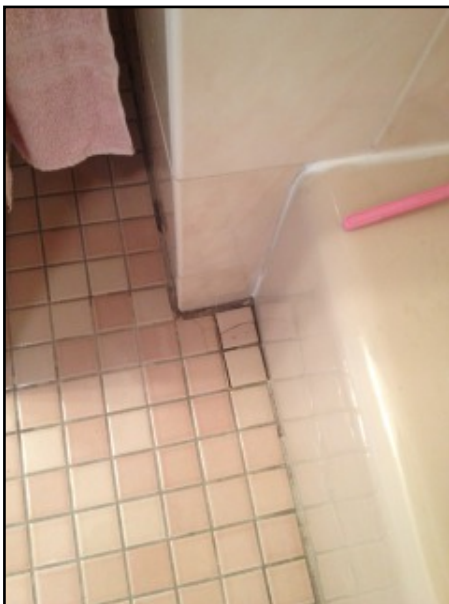
Figure 38-1

In the bathroom, tile floor had grout deterioration adjacent to the bathtub. Repairing this area will help prevent water from getting into floor. This should be done as soon as possible to prevent structural damage and potential mold growth.

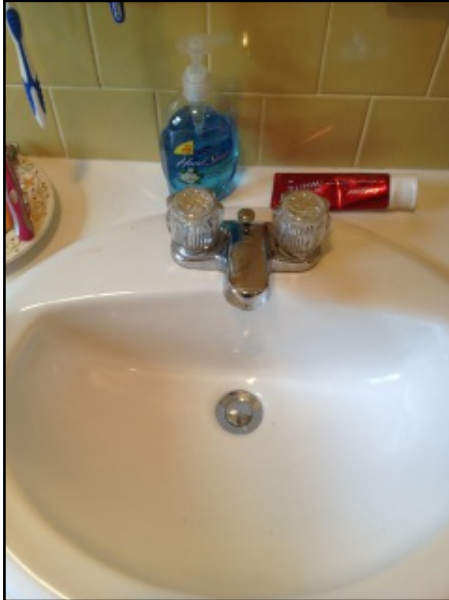
Figure 40-1

The vanity sink stopper mechanism did not operate. This is typically a minor mechanical adjustment or repair.

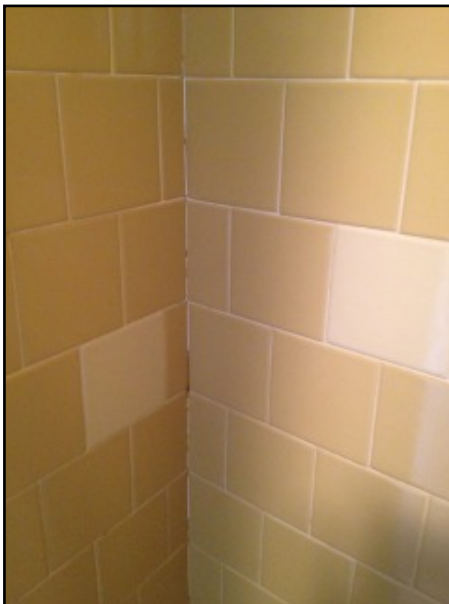
Figure 41-1

The grout on the shower wall shows minor deterioration and cracking. I recommend repairing the grout to prevent water from intruding into the wall causing structural damage. This is a moderate to minor repair.

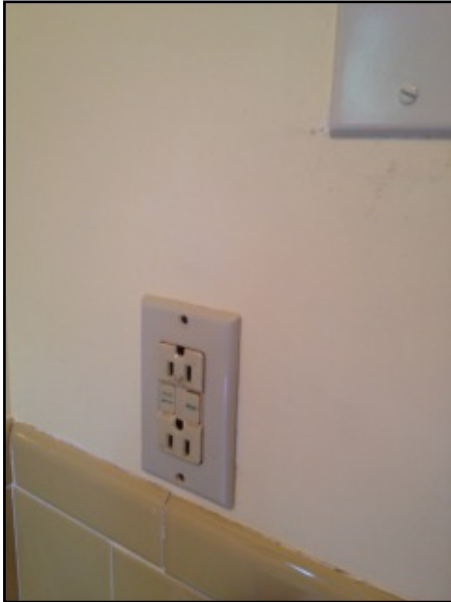
Figure 42-1

The receptacle plate cover is not properly attached. A broken or loose cover can easily move out of place and expose a shock hazard. I recommended replacing the receptacle plate cover. This is a very simple and minor repair.

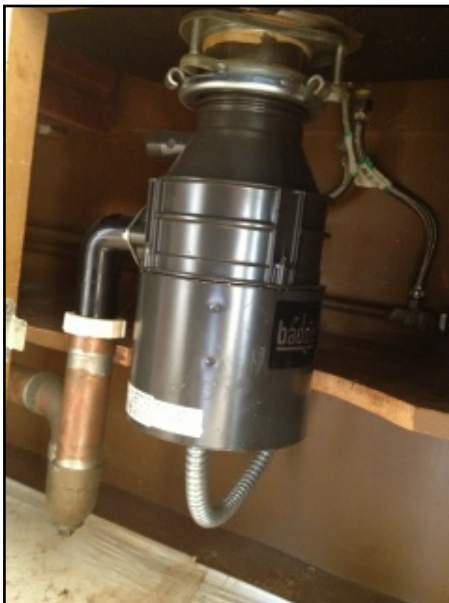
Figure 44-1

I never endorse use of a garbage disposal in a home with a septic system. Garbage disposals put undue stress on a septic system and should not be used. I recommend removal. If a waste disposal machine must be used, at least install a septic system safe style unit.

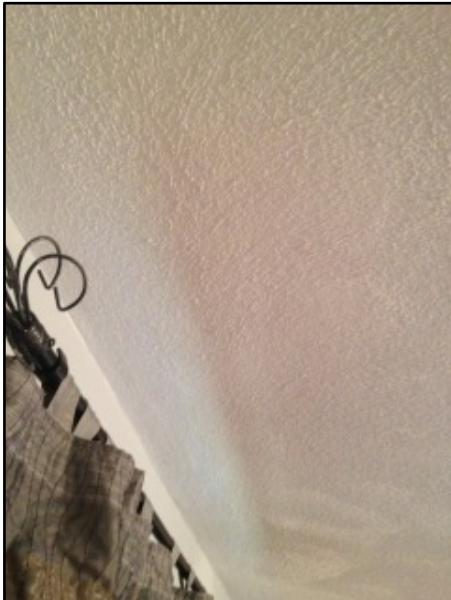
Figure 46-1

The interior bedroom ceiling had discoloration/staining that appeared to be from water. The moisture meter did not detect elevated moisture, indicating a previous leak. This may also be from previous owner using candles or tobacco.

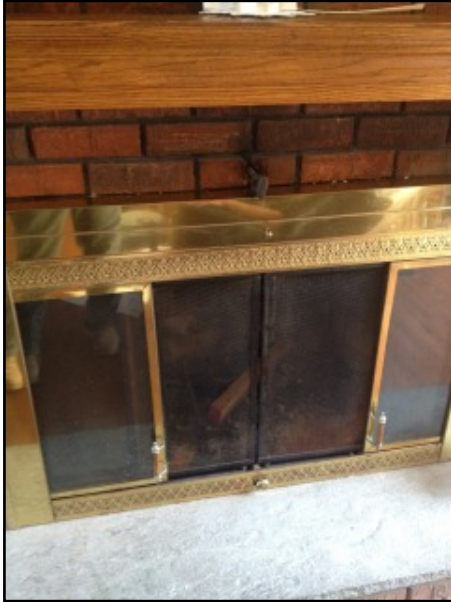
Figure 47-1

The damper did not operate as intended and would not open. Due to a closed damper, the inspector was not able to evaluate the chimney at all. I recommend hiring a chimney specialist to repair the damper, clean the chimney, and provide a full chimney inspection prior to use.

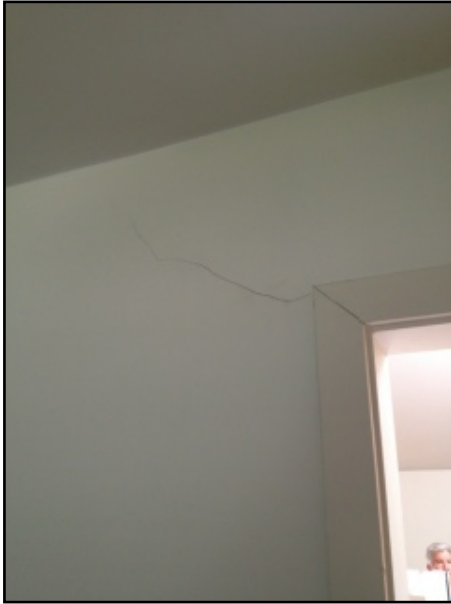
Figure 48-1

The interior wall had minor cracks in some areas on the sheet rock/skimcoat. These are settling cracks and cosmetic only they represent no structural compromise.

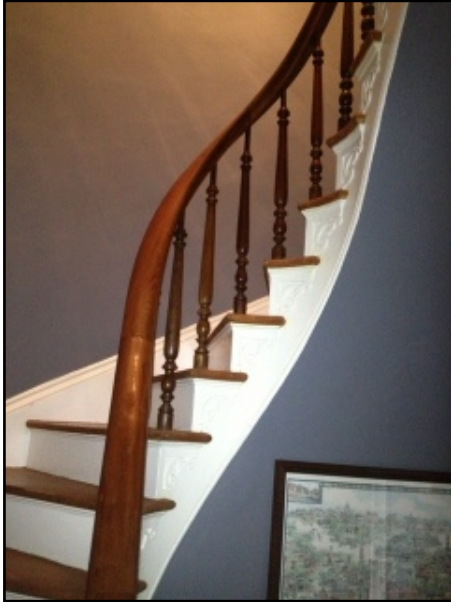
Figure 49-1

The staircase handrail ascending to the second floor was loose at the time of inspection. This rail will only become more loose and hazardous as usage and time continues. I recommend repair by a qualified/licensed contractor or carpenter.

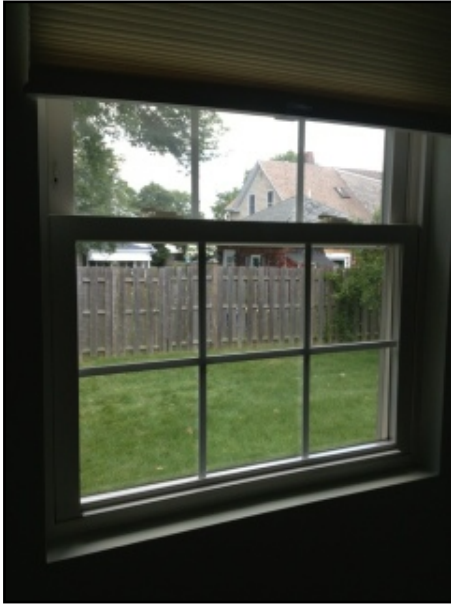
Figure 50-1

The counterweight system on the window did not operate. This means the window will not stay open on it's own. This is, in all likelihood, a minor mechanical repair.

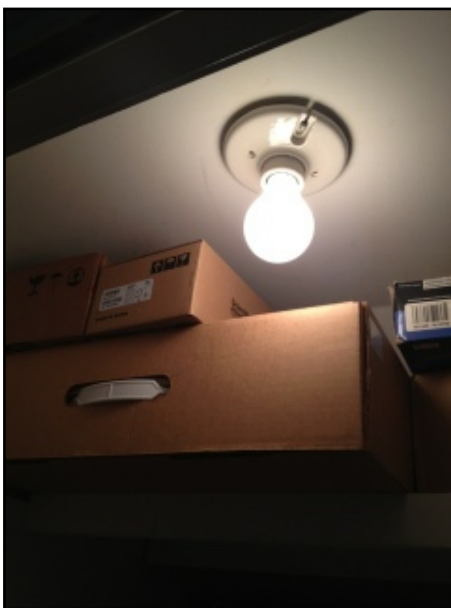
Figure 51-1

I recommend this style of light fixture not to be used inside any closets. Closet lights should be low-profile with protective covering over the bulbs to prevent accidental breakage, lowering the safety hazard, while storing personal items.

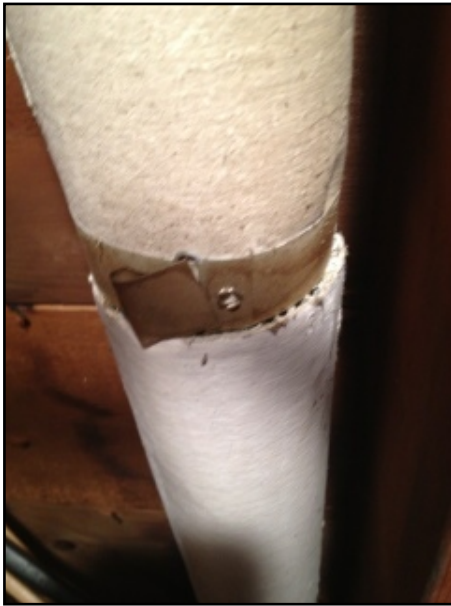
Figure 52-1

The exposed steam radiator pipes in the lower level were insulated in what appears to be asbestos-containing material. Asbestos, when made friable or airborne particles are released, is linked to breathing hazards such as lung cancer and should be treated with extreme caution. I recommend hiring an asbestos removal contractor to properly encapsulate or remove this asbestos containing material from your home. This material should never be handled by anyone other than qualified professionals.

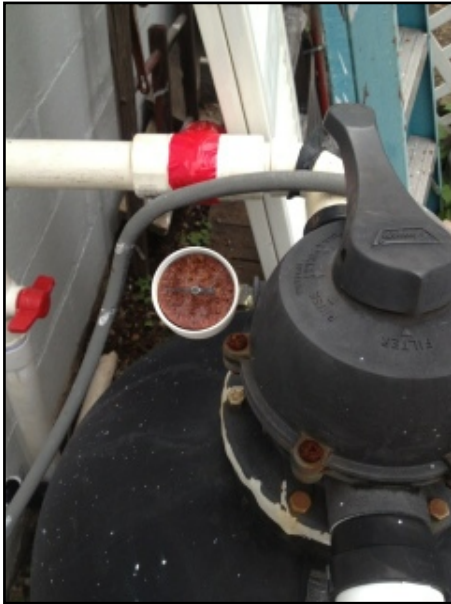
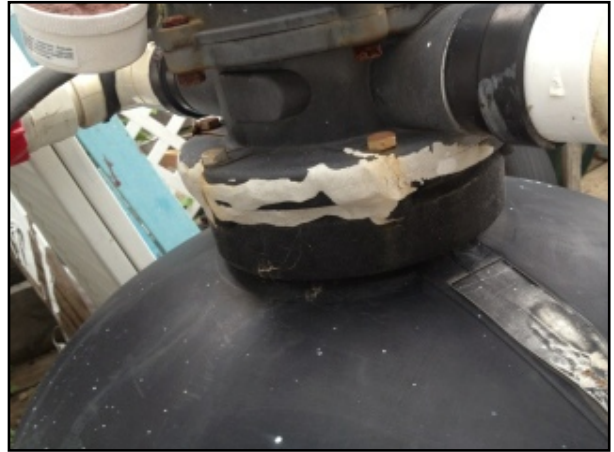
The sand filter had been repaired improperly. The gauge did not operate to display tank pressure. The top of the tank had been repaired with a glue or epoxy making the valve removal impossible. In proper use and care, the top valve should be removed every few years to change the sand inside filter. As currently configured this is not possible and this filters lifespan is only an additional season or two at maximum.

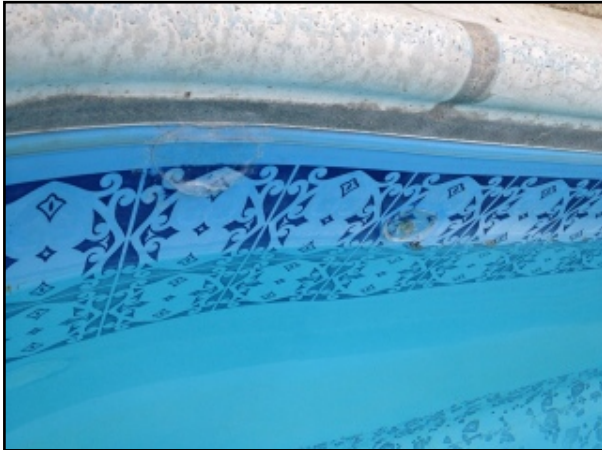
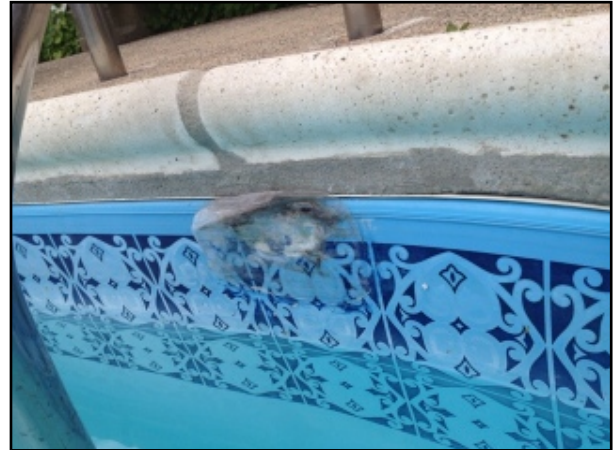
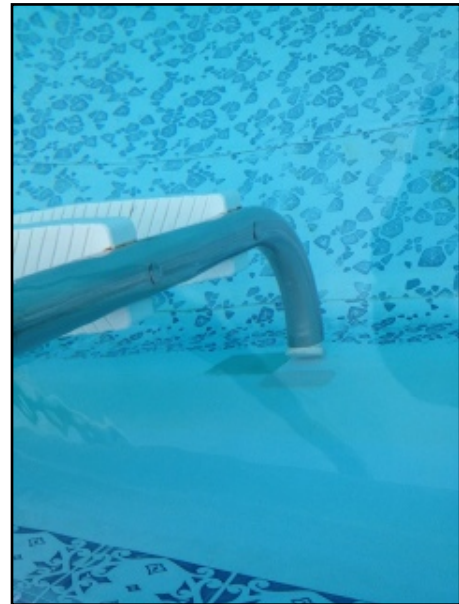
The vinyl pool liner has been patched several times. These patches indicate the liner is reaching the end of its serviceable life. I recommend you budget for replacement in the near future.

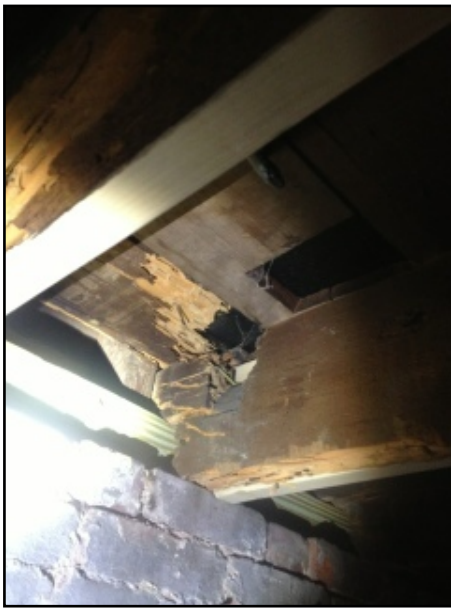
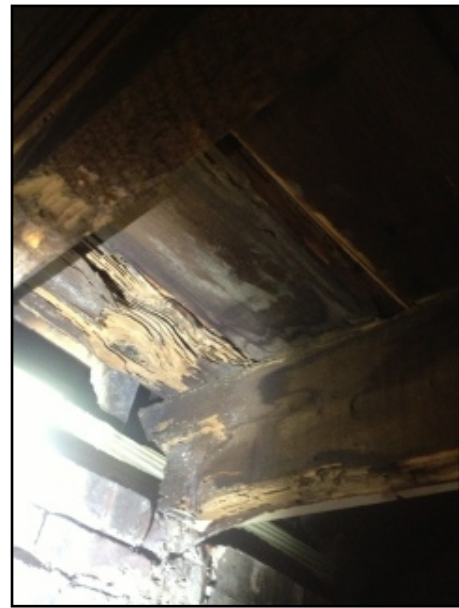
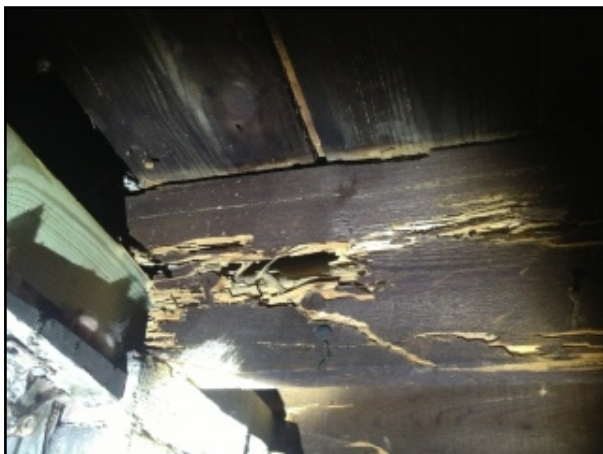
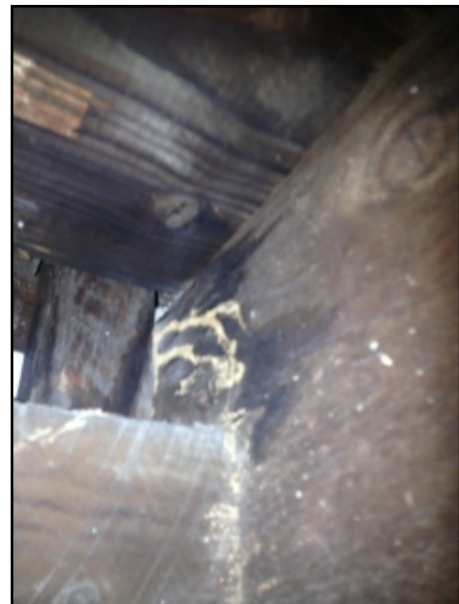
The damage to the floor joists is structural in nature and should be repaired by a qualified, licensed contractor.
