Home Inspection Report

123 Any Street

Quohog, RI 02889

Inspected on Wed, Jul 4 2012 at 6:00 AM

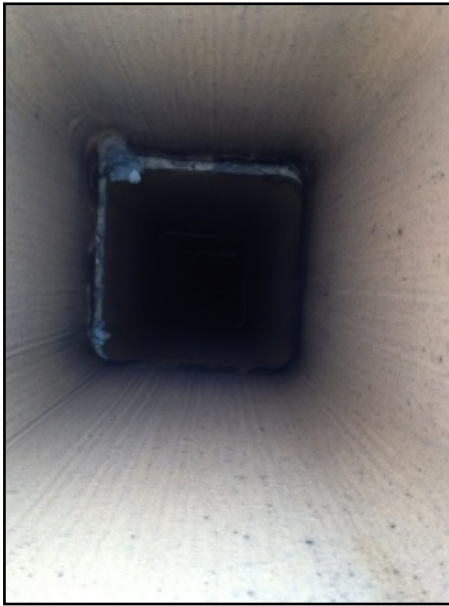
Figure 15-3

The chimney liner for the fireplace flue (fig 15-3) is in good condition with no cracking or shifting of the lining sections.

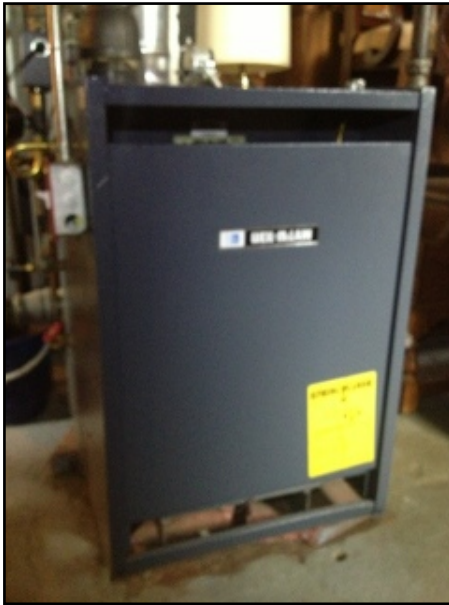
Figure 27-1

Comment 27:
Informational photo of your boiler.

Furnaces over 10 years old should be checked, cleaned and serviced yearly by a licensed contractor.

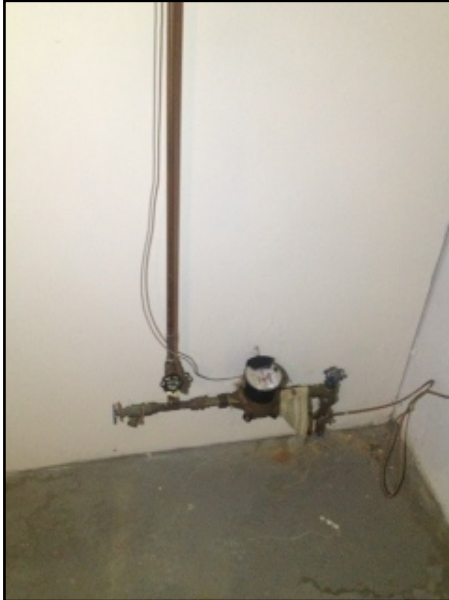
Figure 34-1

Informational photo, this is your water meter and main water shut off. Located in the south west corner of the basement.

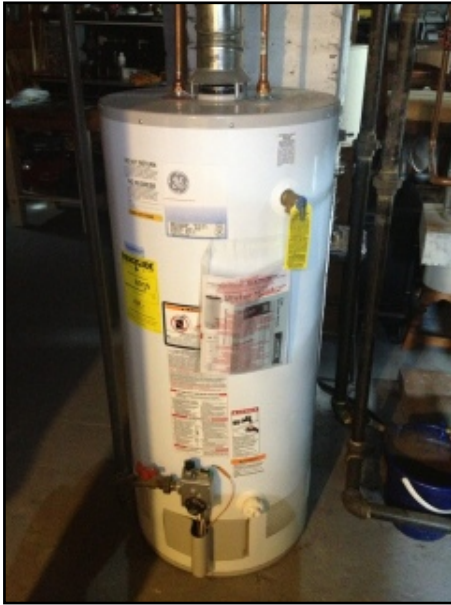
Figure 35-1

Comment 35:
Informational photo of your water heater.

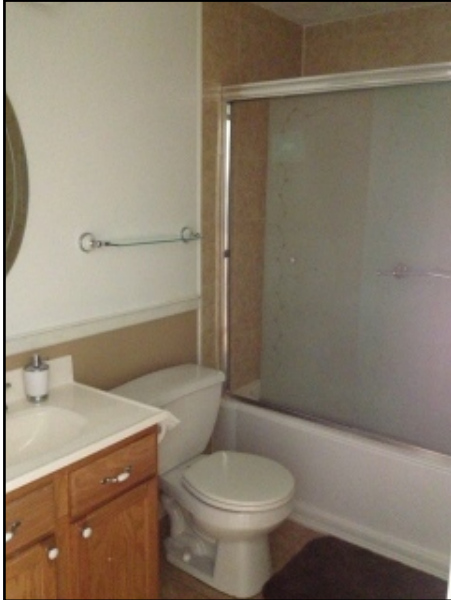
Figure 36-1

Informational photo of the bathroom (number 1).

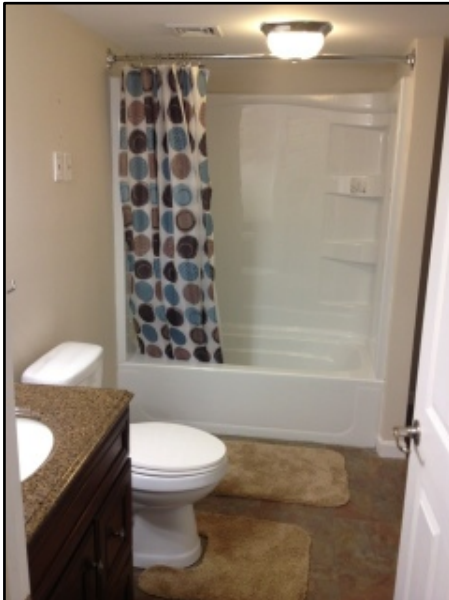
Figure 39-1

Comment 39:
Informational photo of the bathroom (number 2).

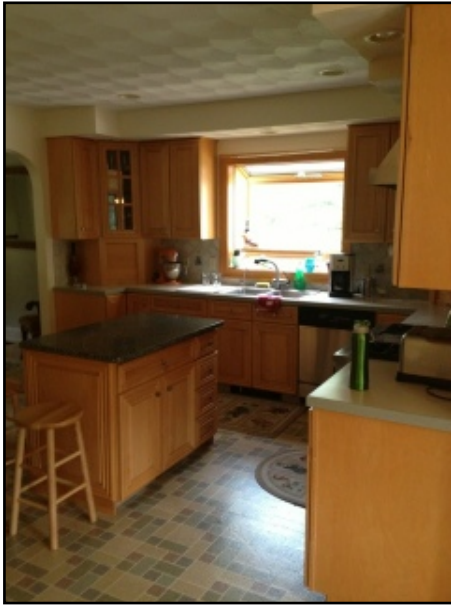
Figure 43-1

Comment 43:
Informational photo of the kitchen.
